## Electromagnetic Field Measurement Survey

**BS Number: 36**

**Site Name: Broadhurst Methodist Church**

**Site visit date: 27 October 2010**

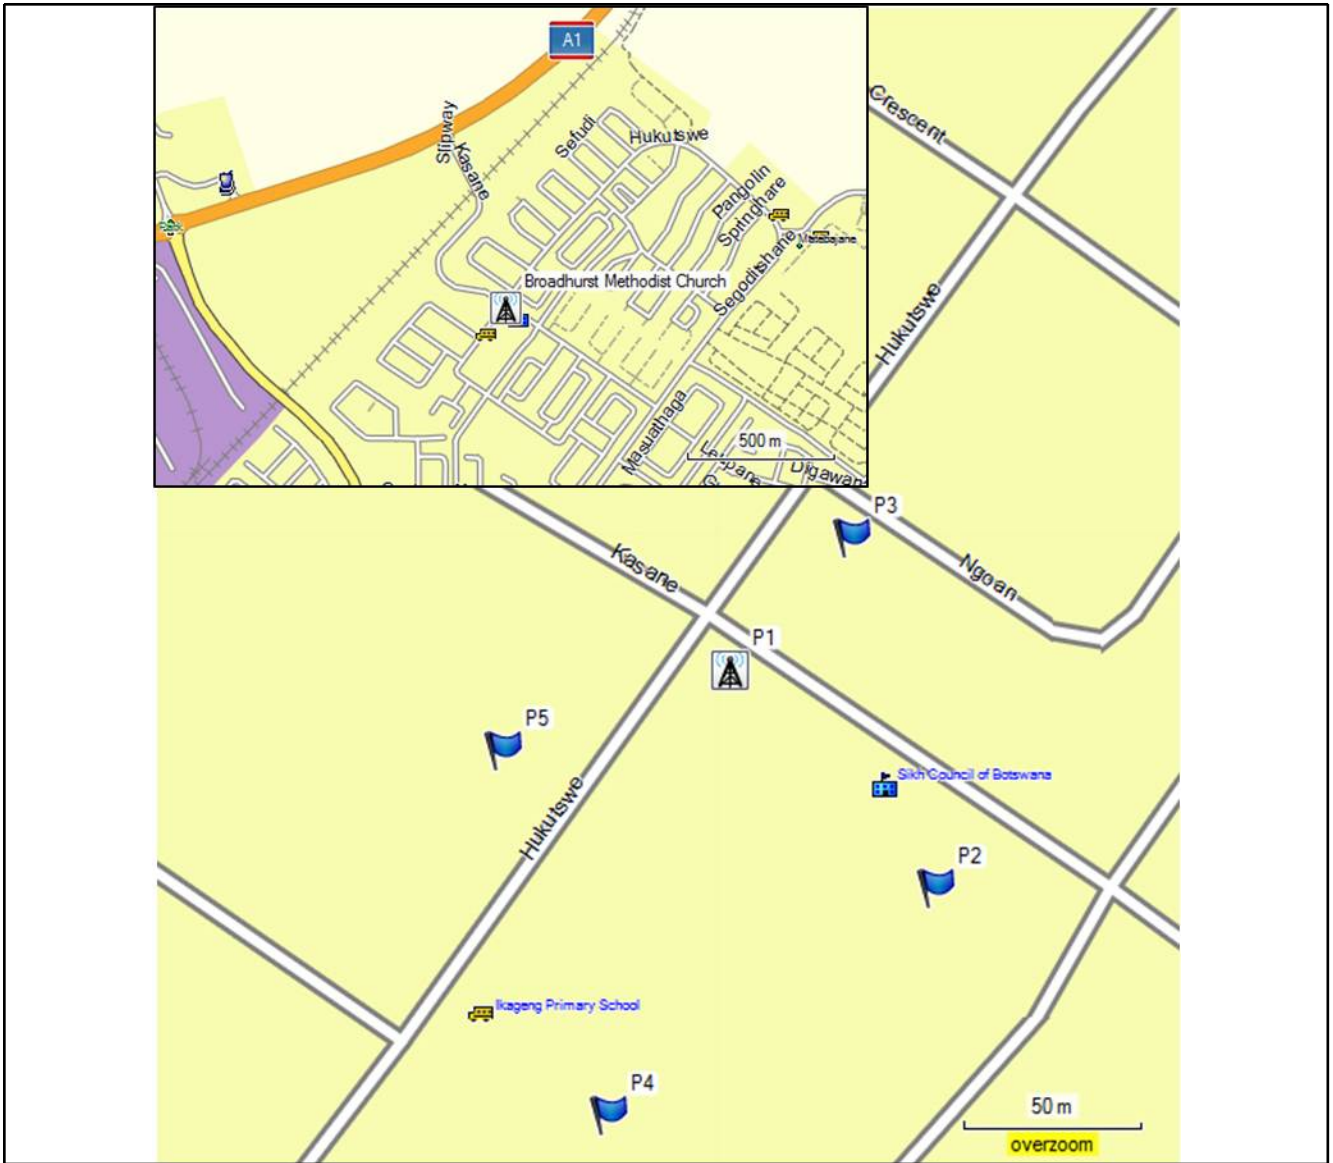
**Figure 1: Map of Area around Base Station Site and Measurement Positions**

Table 1 and Figure 1 presents the measured positions and exposure levels in terms of a percentage of the ICNIRP guidelines, where a 100% value would indicate that the safe exposure limit for the General Public has been reached. The total exposure is given in the first column of the table. Since the aim of the survey was to measure the typical exposure values, the reported results are un-extrapolated peak field instantaneous exposure results, at the specific date and time of the measurement survey.

For the measured results presented in this report a 100% value would indicate that the ICNIRP exposure limit for the General Public has been reached. The highest value measured is 0.0088% of the ICNIRP General Public guidelines and was obtained at position 2. This is more than 11410 times below the General Public limit.
