## Electromagnetic Field Measurement Survey

**BS Number: 35**

**Site Name: Mochudi Police**

**Site visit date: 28 October 2010**

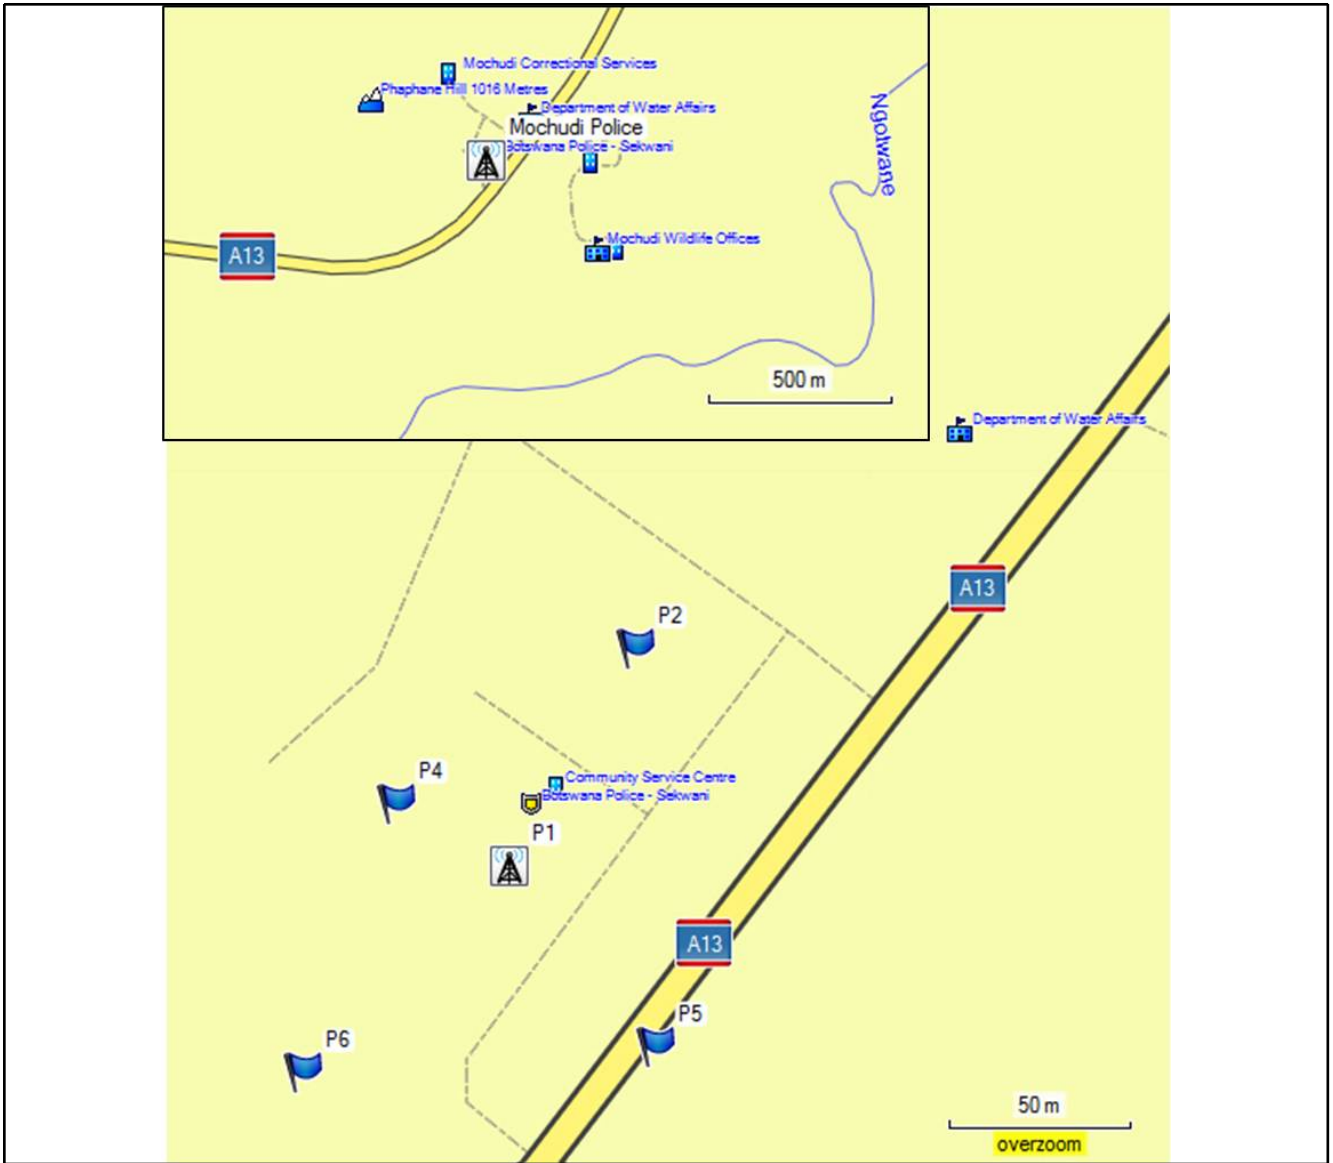
**Figure 1: Map of Area around Base Station Site and Measurement Positions**

Table 1 and Figure 1 presents the measured positions and exposure levels in terms of a percentage of the ICNIRP guidelines, where a 100% value would indicate that the safe exposure limit for the General Public has been reached. The total exposure is given in the first column of the table. Since the aim of the survey was to measure the typical exposure values, the reported results are un-extrapolated peak field instantaneous exposure results, at the specific date and time of the measurement survey.

For the measured results presented in this report a 100% value would indicate that the ICNIRP exposure limit for the General Public has been reached. The highest value measured is 0.0180% of the ICNIRP General Public guidelines and was obtained at position 5. This is more than 5540 times below the General Public limit.
