Electromagnetic Field Measurement Survey

BS Number: 5

Site Name: Mogoditshane

Site visit date: 27 August 2010

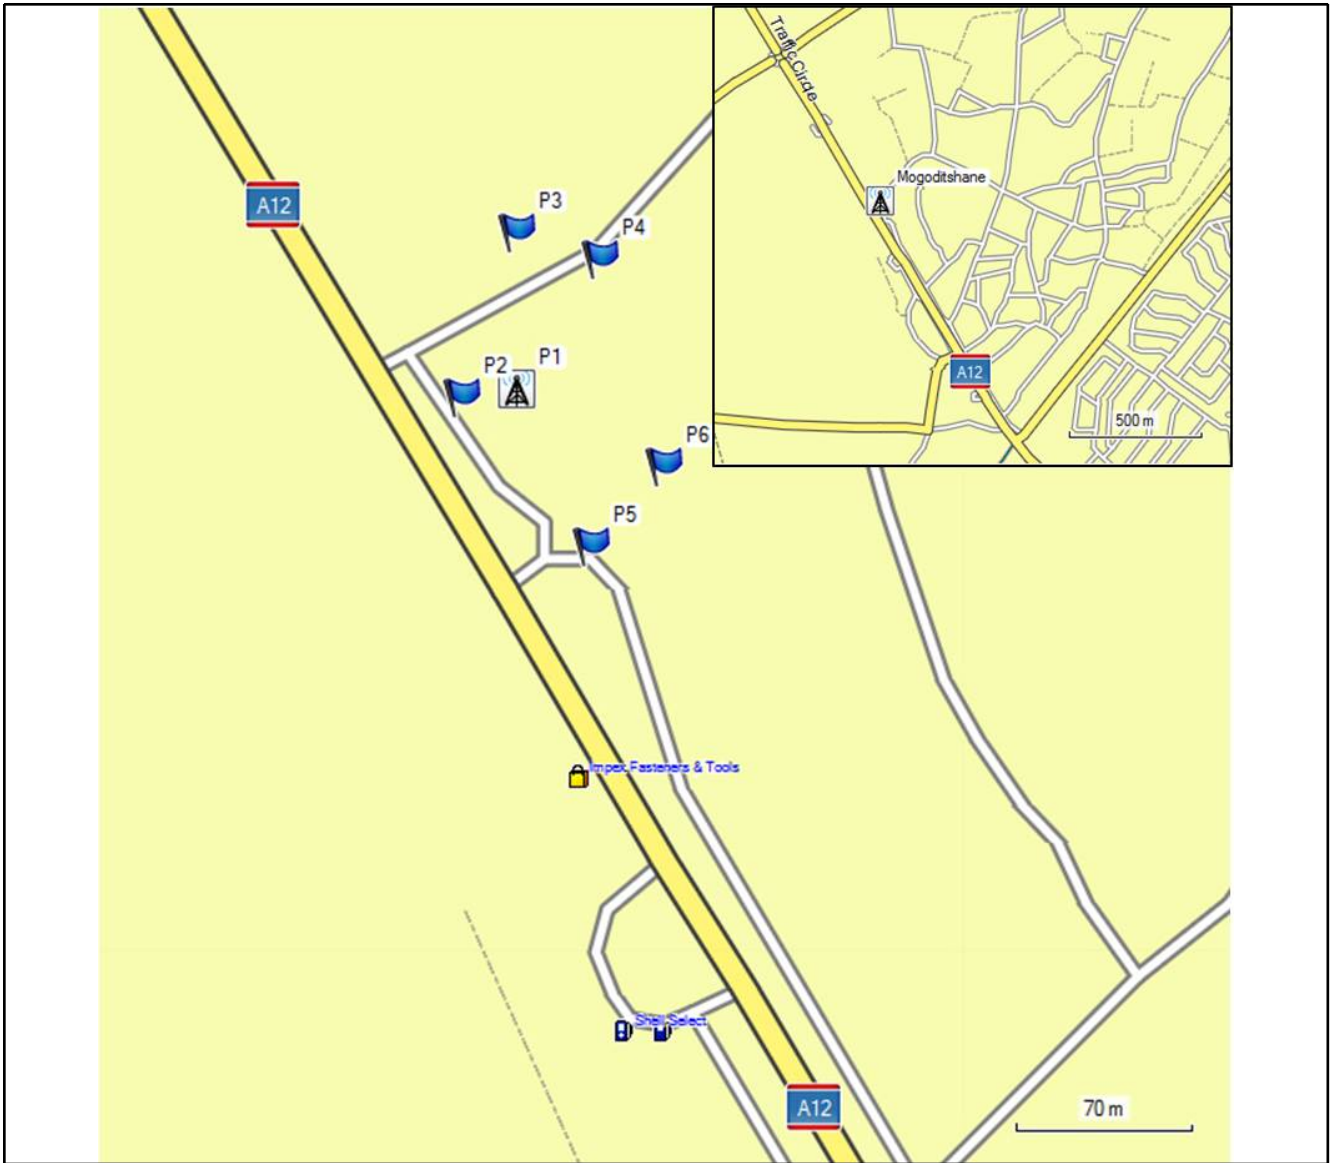
Figure 1: Map of Area around Base Station Site and Measurement Positions

Table 1 and Figure 1 presents the measured positions and exposure levels in terms of a percentage of the ICNIRP guidelines, where a 100% value would indicate that the safe exposure limit for the General Public has been reached. The total exposure is given in the first column of the table. Since the aim of the survey was to measure the typical exposure values, the reported results are un-extrapolated peak field instantaneous exposure results, at the specific date and time of the measurement survey.

For the measured results presented in this report a 100% value would indicate that the ICNIRP exposure limit for the General Public has been reached. The highest value measured is 0.0423% of the ICNIRP General Public guidelines and was obtained at position 4. This is more than 2360 times below the General Public limit.
