Electromagnetic Field Measurement Survey

BS Number: 10

Site Name: Tlokweng

Site visit date: 25 October 2010

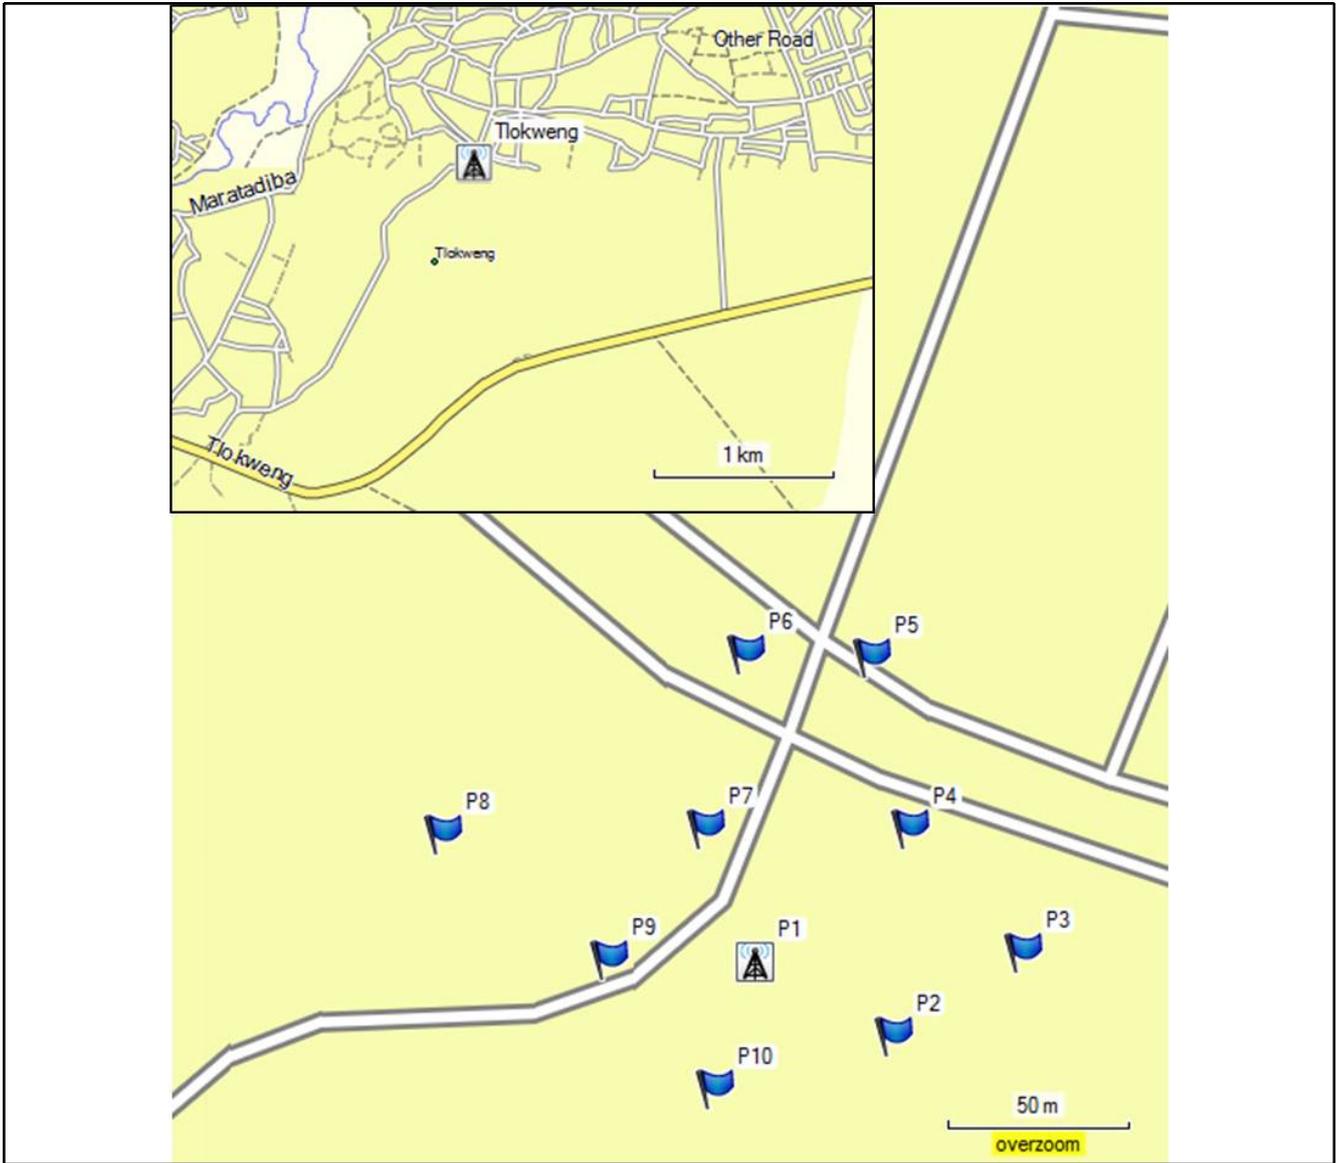
Figure 1: Map of Area around Base Station Site and Measurement Positions

Table 1 and Figure 1 presents the measured positions and exposure levels in terms of a percentage of the ICNIRP guidelines, where a 100% value would indicate that the safe exposure limit for the General Public has been reached. The total exposure is given in the first column of the table. Since the aim of the survey was to measure the typical exposure values, the reported results are un-extrapolated peak field instantaneous exposure results, at the specific date and time of the measurement survey.

For the measured results presented in this report a 100% value would indicate that the ICNIRP exposure limit for the General Public has been reached. The highest value measured is 0.0572% of the ICNIRP General Public guidelines and was obtained at position 7. This is more than 1740 times below the General Public limit.
