## Electromagnetic Field Measurement Survey

**BS Number: 3**

**Site Name: BBS**

**Site visit date: 30 August 2010**

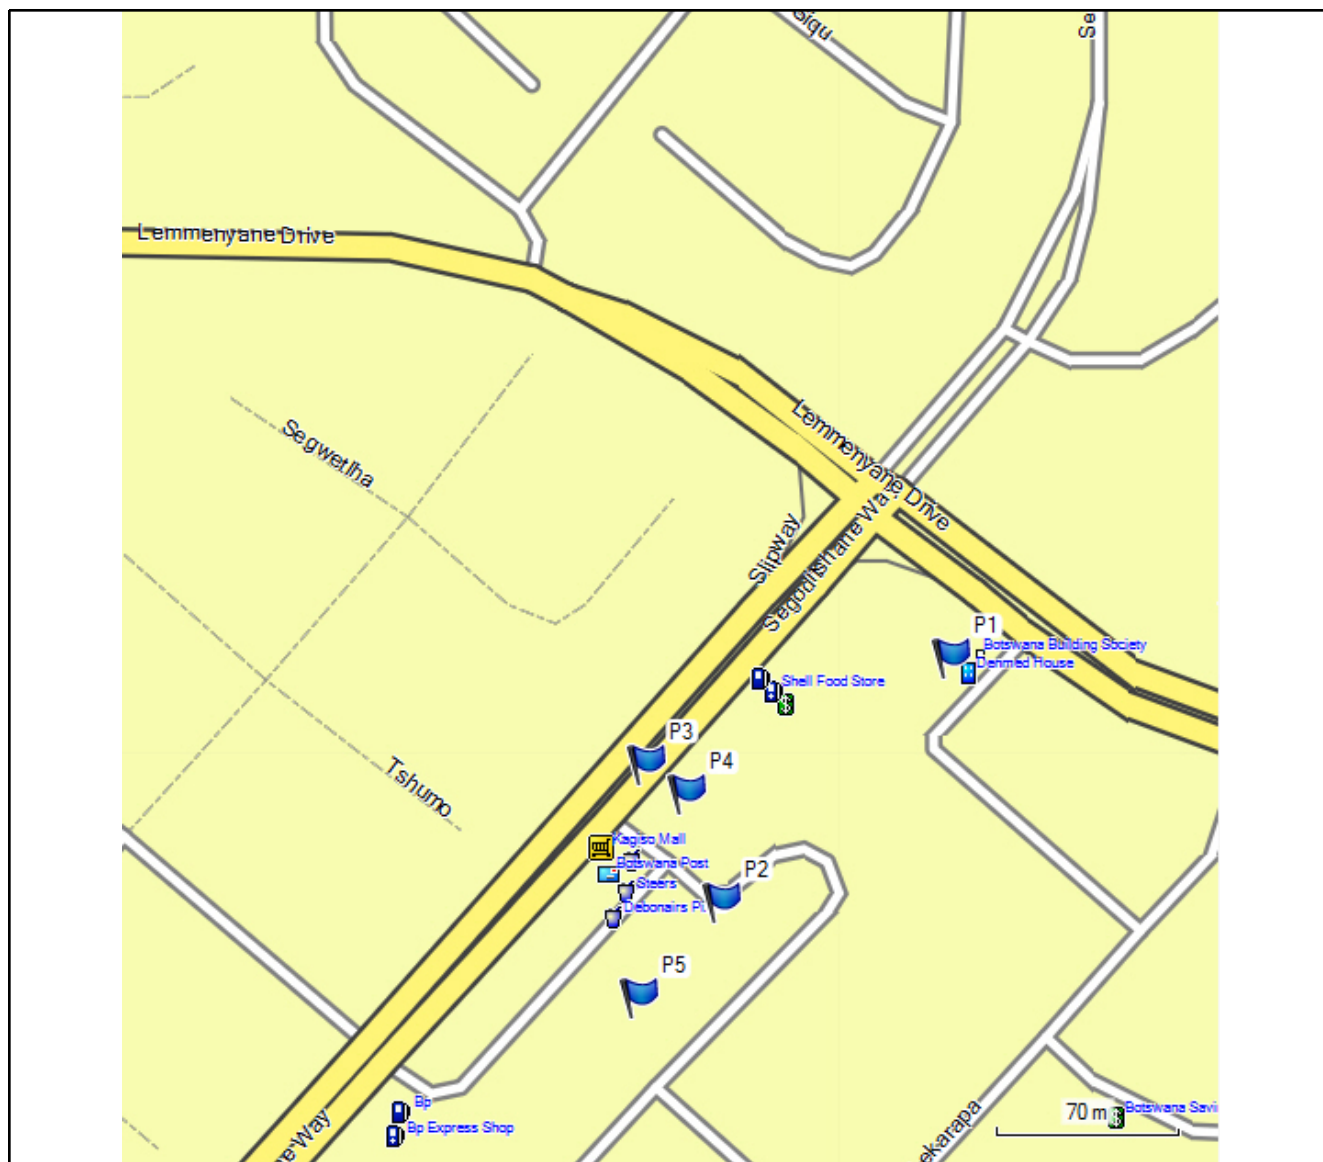
**Figure 1: Map of Area around Base Station Site and Measurement Positions**

Table 1 and Figure 1 presents the measured positions and exposure levels in terms of a percentage of the ICNIRP guidelines, where a 100% value would indicate that the safe exposure limit for the General Public has been reached. The total exposure is given in the first column of the table. Since the aim of the survey was to measure the typical exposure values, the reported results are un-extrapolated peak field instantaneous exposure results, at the specific date and time of the measurement survey.

For the measured results presented in this report a 100% value would indicate that the ICNIRP exposure limit for the General Public has been reached. The highest value measured is 0.0826% of the ICNIRP General Public guidelines and was obtained at position 3. This is more than 1210 times below the General Public limit.
