## Electromagnetic Field Measurement Survey

**BS Number: 13**

**Site Name: Kgale Mews**

**Site visit date: 26 October 2010**

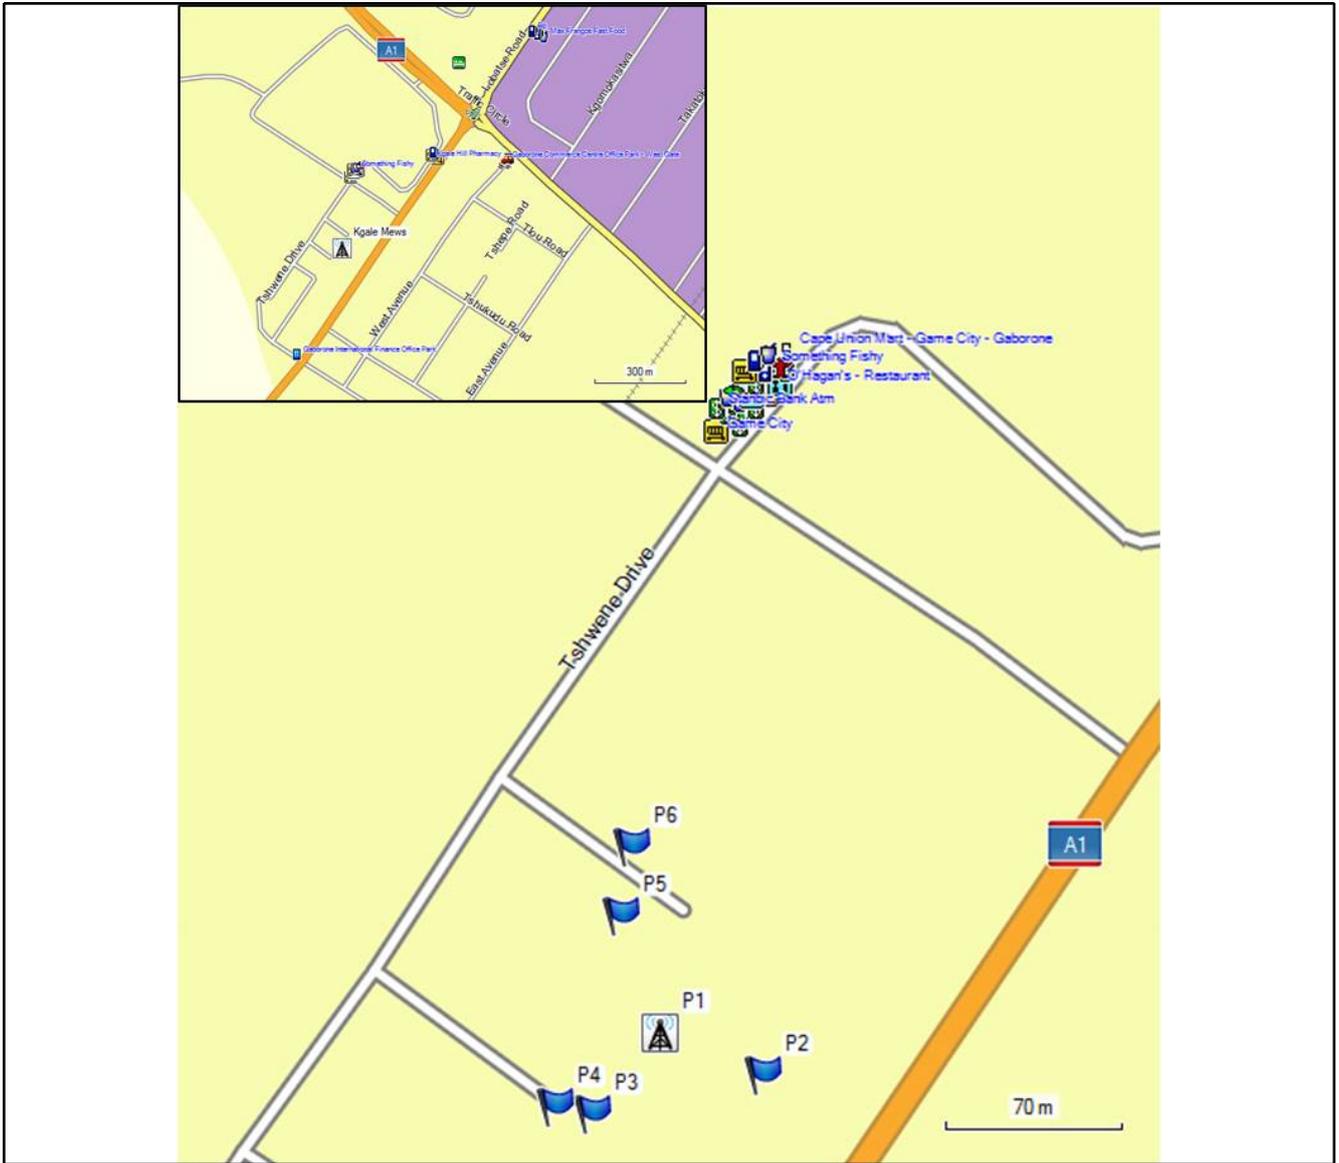
**Figure 1: Map of Area around Base Station Site and Measurement Positions**

Table 1 and Figure 1 presents the measured positions and exposure levels in terms of a percentage of the ICNIRP guidelines, where a 100% value would indicate that the safe exposure limit for the General Public has been reached. The total exposure is given in the first column of the table. Since the aim of the survey was to measure the typical exposure values, the reported results are un-extrapolated peak field instantaneous exposure results, at the specific date and time of the measurement survey.

For the measured results presented in this report a 100% value would indicate that the ICNIRP exposure limit for the General Public has been reached. The highest value measured is 0.0240% of the ICNIRP General Public guidelines and was obtained at position 2. This is more than 4170 times below the General Public limit.
