Electromagnetic Field Measurement Survey

BS Number: 32

Site Name: Morwa

Site visit date: 27 October 2010

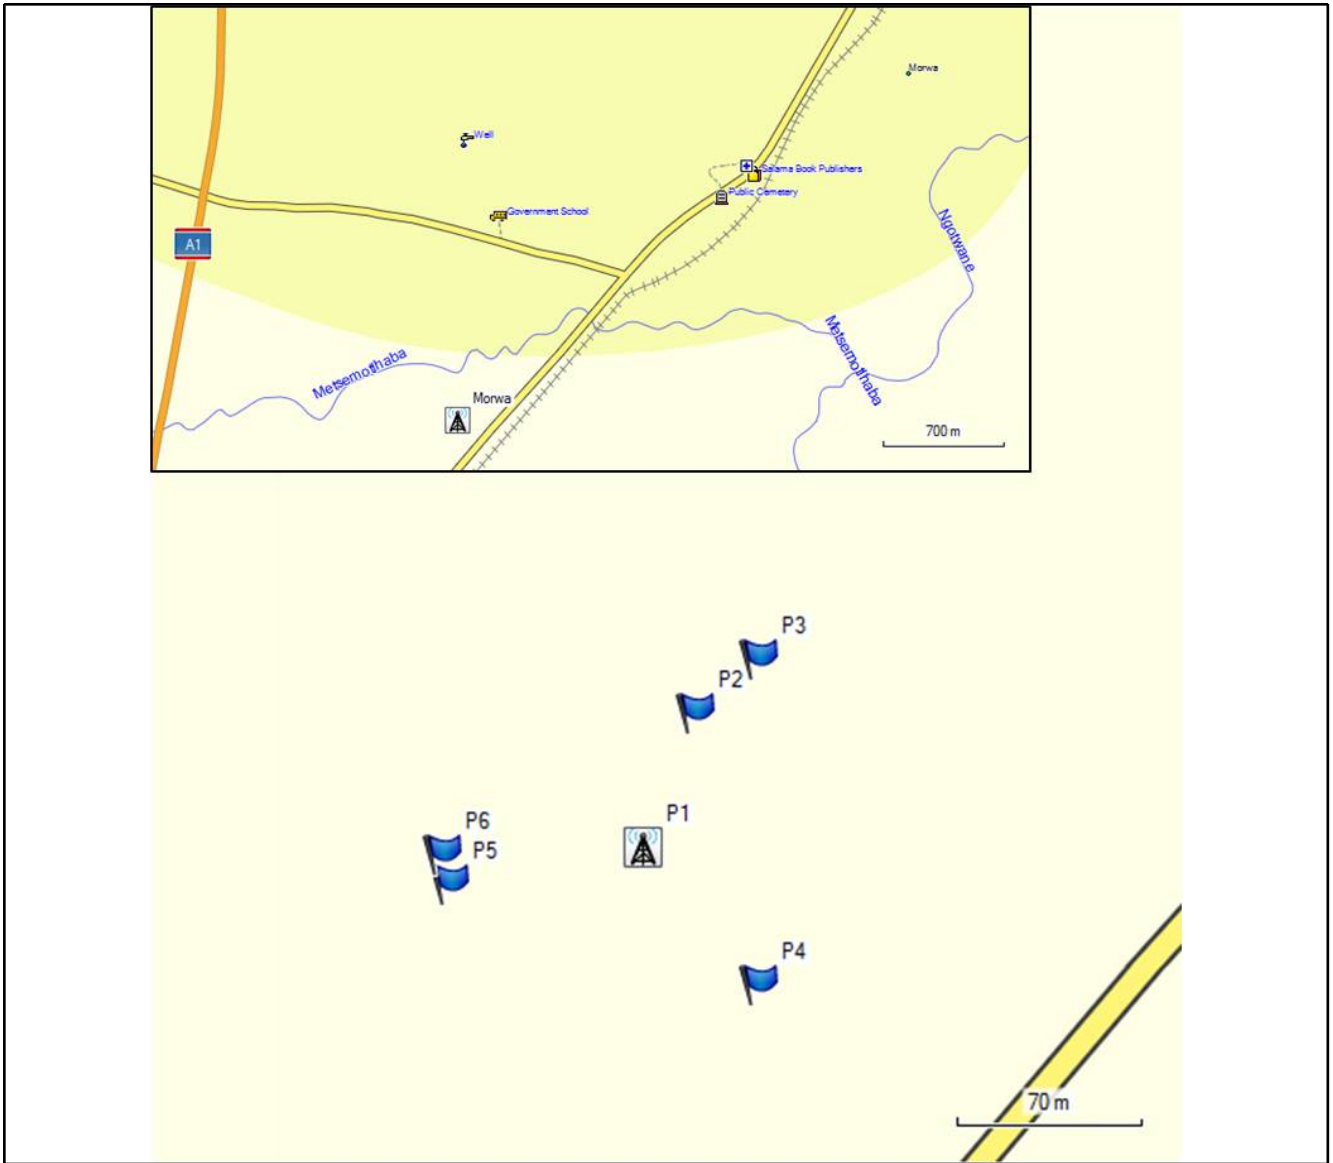
Figure 1: Map of Area around Base Station Site and Measurement Positions

Table 1 and Figure 1 presents the measured positions and exposure levels in terms of a percentage of the ICNIRP guidelines, where a 100% value would indicate that the safe exposure limit for the General Public has been reached. The total exposure is given in the first column of the table. Since the aim of the survey was to measure the typical exposure values, the reported results are un-extrapolated peak field instantaneous exposure results, at the specific date and time of the measurement survey.

For the measured results presented in this report a 100% value would indicate that the ICNIRP exposure limit for the General Public has been reached. The highest value measured is 0.0120% of the ICNIRP General Public guidelines and was obtained at position 3. This is more than 8340 times below the General Public limit.
