## Electromagnetic Field Measurement Survey

**BS Number: 6**

**Site Name: Phase4**

**Site visit date: 26 October 2010**

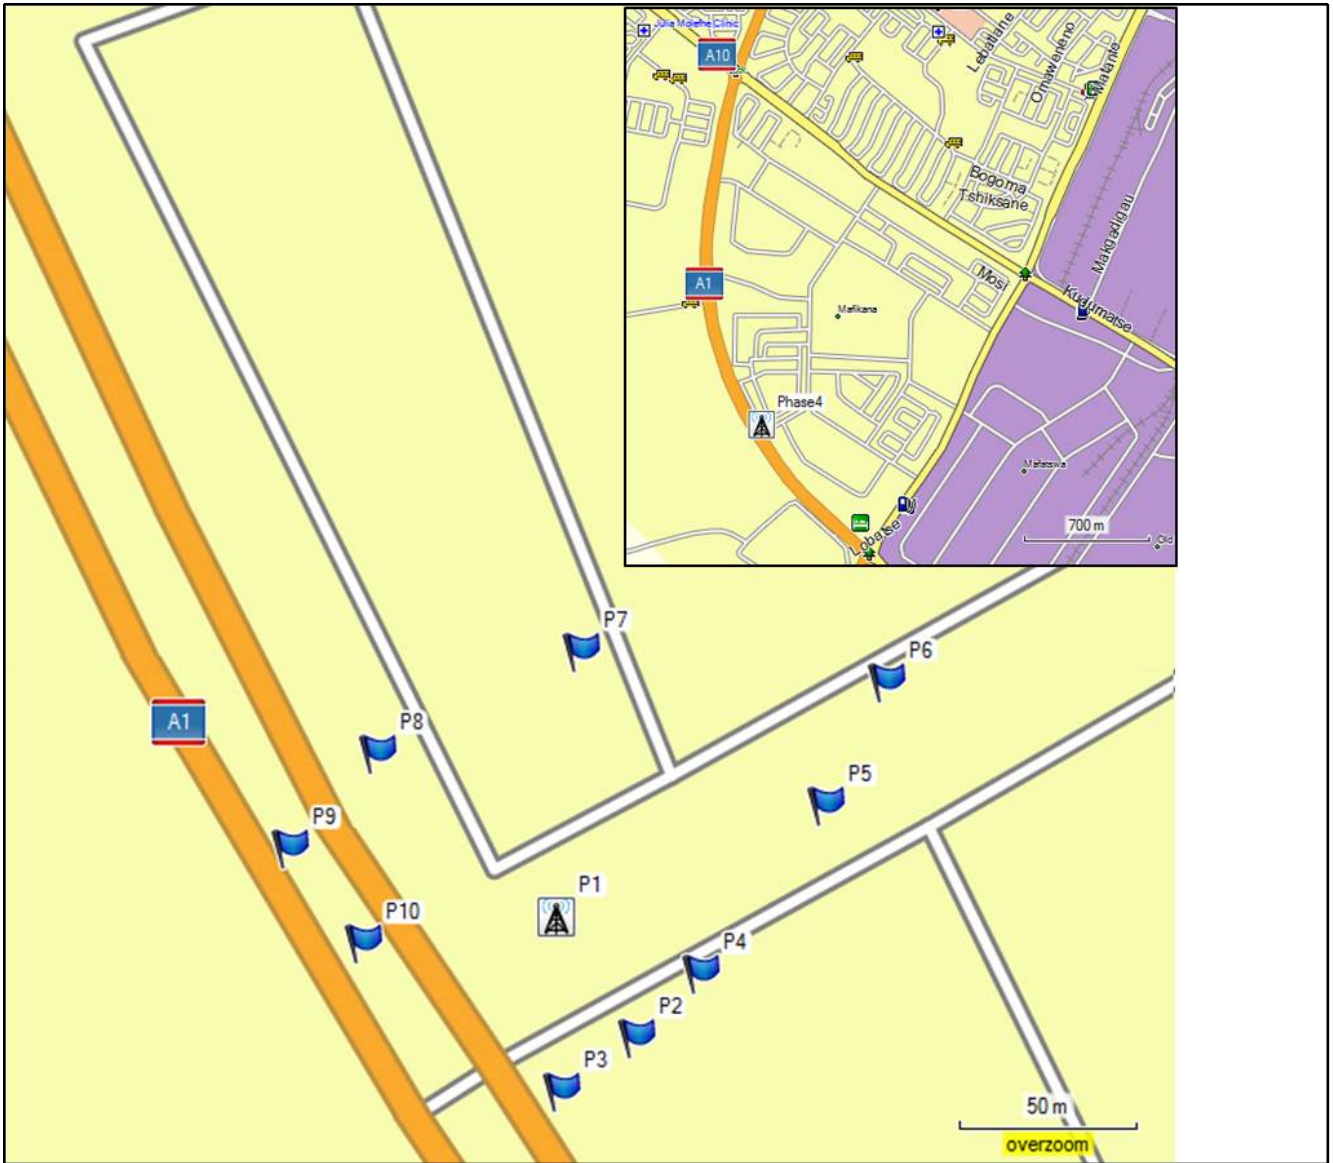
**Figure 1: Map of Area around Base Station Site and Measurement Positions**

Table 1 and Figure 1 presents the measured positions and exposure levels in terms of a percentage of the ICNIRP guidelines, where a 100% value would indicate that the safe exposure limit for the General Public has been reached. The total exposure is given in the first column of the table. Since the aim of the survey was to measure the typical exposure values, the reported results are un-extrapolated peak field instantaneous exposure results, at the specific date and time of the measurement survey.

For the measured results presented in this report a 100% value would indicate that the ICNIRP exposure limit for the General Public has been reached. The highest value measured is 0.0517% of the ICNIRP General Public guidelines and was obtained at position 1. This is more than 1930 times below the General Public limit.
