Electromagnetic Field Measurement Survey

BS Number: 12

Site Name: Showground

Site visit date: 25 October 2010

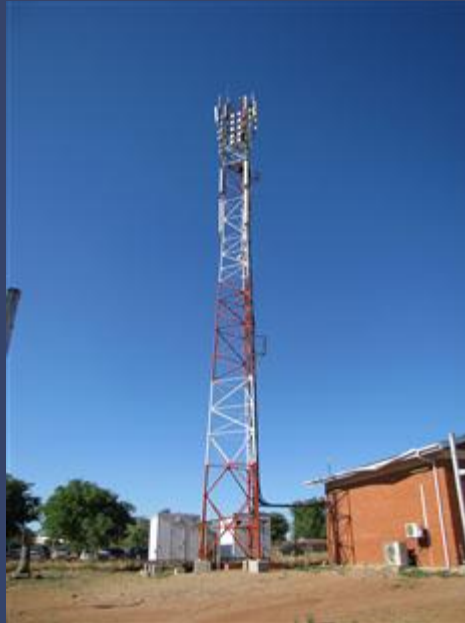
Table 1 and Figure 1 presents the measured positions and exposure levels in terms of a percentage of the ICNIRP guidelines, where a 100% value would indicate that the safe exposure limit for the General Public has been reached. The total exposure is given in the first column of the table. Since the aim of the survey was to measure the typical exposure values, the reported results are un-extrapolated peak field instantaneous exposure results, at the specific date and time of the measurement survey.

For the measured results presented in this report a 100% value would indicate that the ICNIRP exposure limit for the General Public has been reached. The highest value measured is 0.0949% of the ICNIRP General Public guidelines and was obtained at position 7. This is more than 1050 times below the General Public limit.
