Electromagnetic Field Measurement Survey

BS Number: 11

Site Name: Tsholofelo

Site visit date: 27 October 2010

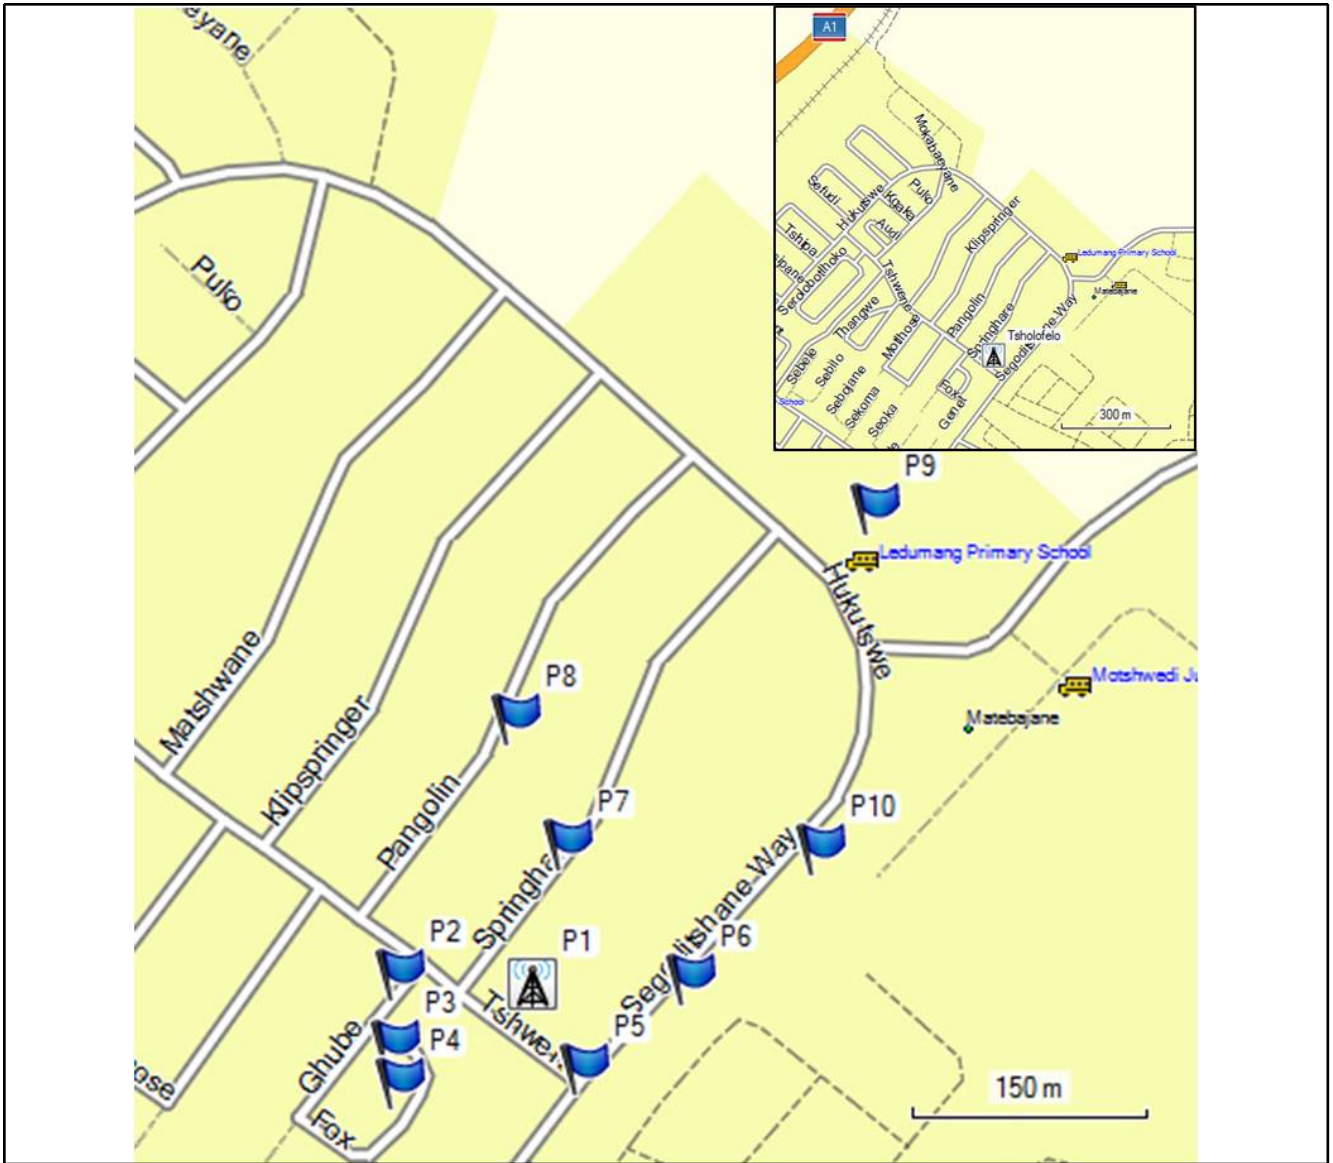
Figure 1: Map of Area around Base Station Site and Measurement Positions

Table 1 and Figure 1 presents the measured positions and exposure levels in terms of a percentage of the ICNIRP guidelines, where a 100% value would indicate that the safe exposure limit for the General Public has been reached. The total exposure is given in the first column of the table. Since the aim of the survey was to measure the typical exposure values, the reported results are un-extrapolated peak field instantaneous exposure results, at the specific date and time of the measurement survey.

For the measured results presented in this report a 100% value would indicate that the ICNIRP exposure limit for the General Public has been reached. The highest value measured is 0.0159% of the ICNIRP General Public guidelines and was obtained at position 10. This is more than 6290 times below the General Public limit.
